ENERGY TECHNOLOGY ENGINEERING CENTER

No. 029-AR-0001 Rev.

TITLE: FINAL D&D REPORT FOR BLDG. T029

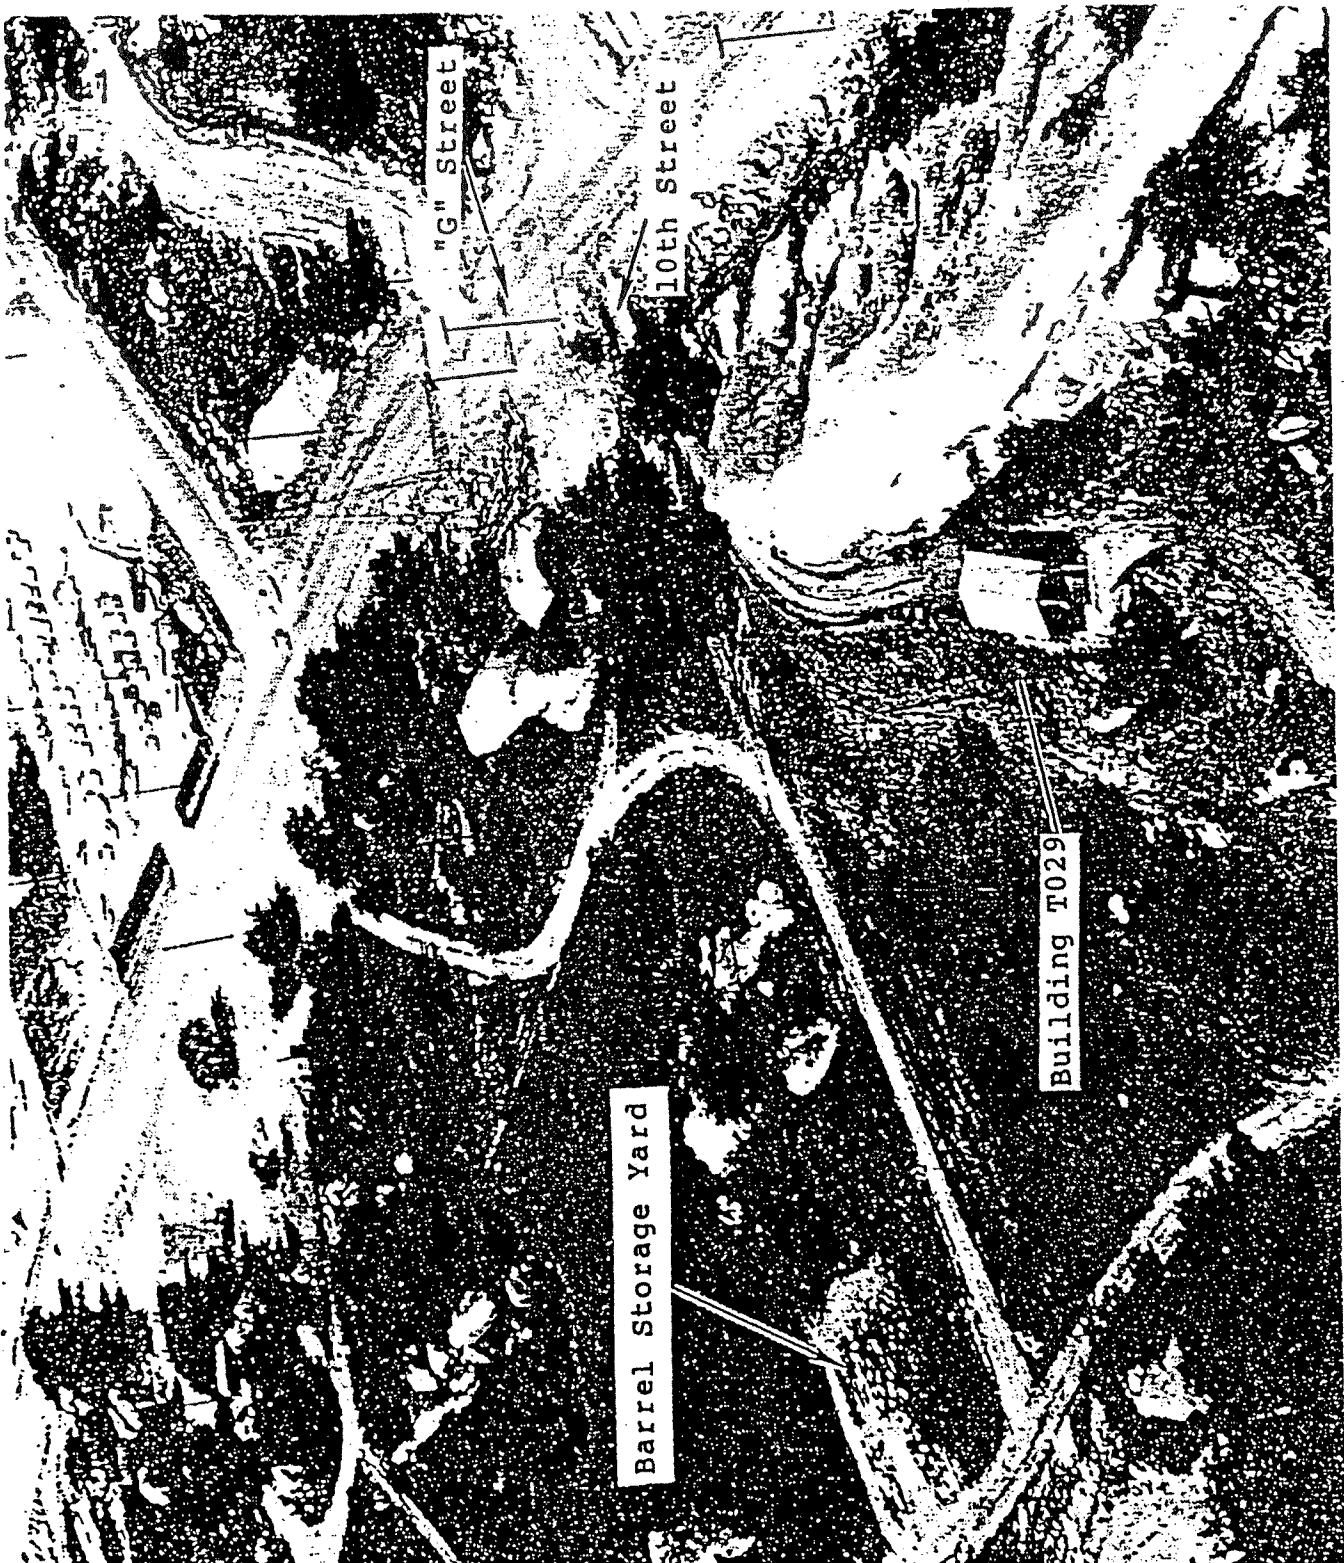
Figure 1-5. Photograph of T029 Looking South Southwest

Figure 1-4 is a plot plan of the western portion of SSFL (known as "Area IV") where Building T029 is located. As shown in this figure, access to T029 is by way of 10th Street, which intersects "G" Street just southwest of building T064. An asphalt roadway (10th Street) runs right up to the facility. A portion of the roadway is fenced in as part of the facility. Figure 1-5 is an old photograph of T029 and the surrounding area, looking south-southwest. Figure 1-6 shows the entrance gate on 10th Street and the west wall of T029, and Figure 1-7 shows a close-up view from the south.
